RESERVOIRS

The chapter on Masonry Dams has been increased twofold by an attempt to make some mention of all the most notable dams of the world, and many that are very little known. Attention is particularly directed to Plates 1, 2, and 3, in which profiles are shown of all of the leading and better known masonry dams in existence, drawn to uniform scale for easy graphical comparison. No such complete collection of dam profiles has ever before appeared in print, assembled together on a common basis.

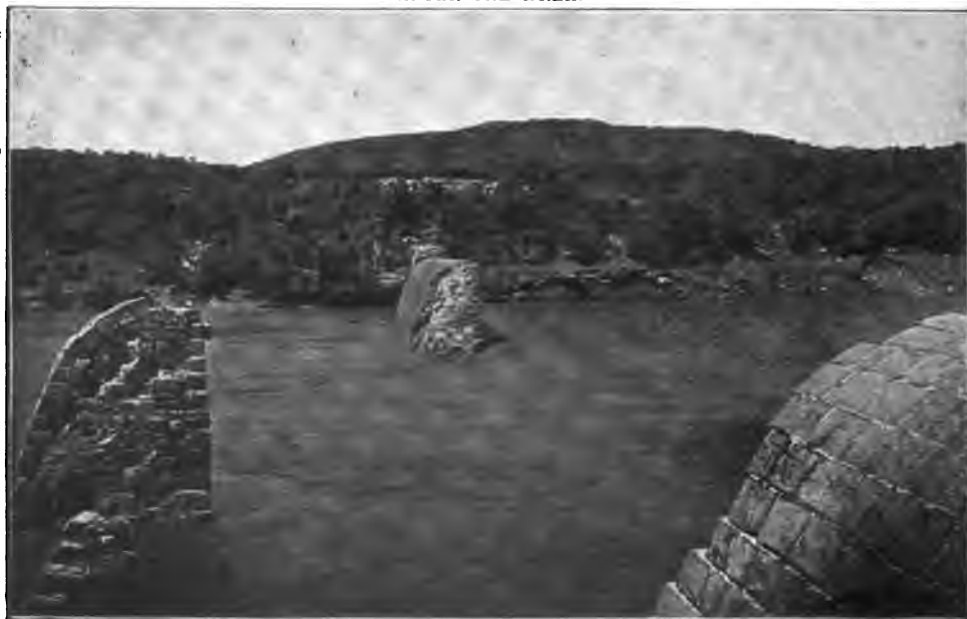
F.G. 231.—AUSTIN DAM, TEXAS, AFTER SUBSIDENCE OF FLOOD OF APRIL 7, 1900. Showing section of masonry moved bodily down-stream.

posited. Measured along the crest, the break left about 500 feet of the dam at the west end and 83 feet at the east end still unaffected. About two-thirds of the wall of the power-house below the dam next the river was also destroyed by the flood. The entire property loss must have exceeded \$500,000. At the time of the break the lake-level had reached a height of 11.07 feet above the crest. The flood was the result of extraordinary rains throughout a very extensive watershed area. In fifteen hours the rainfall at Austin and vicinity was 5 inches, falling on ground already well soaked by previous rains. The maximum flood prior to the catastrophe occurred June 7, 1899, when the water rose to 9.8 feet above the crest of the dam, without injury to the structure. The dam will probably be rebuilt upon safer plans, and precautions taken to anchor it into bed-rock a sufficient depth to prevent it from sliding on its foundations.

The appearance of the dam immediately before the break is shown in Fig. 229. Figs. 230 and 231 graphically present the break and the bodily movement of a section of the dam down-stream intact, better than any detailed description. The author is indebted to *Engineering News* for these three cuts.

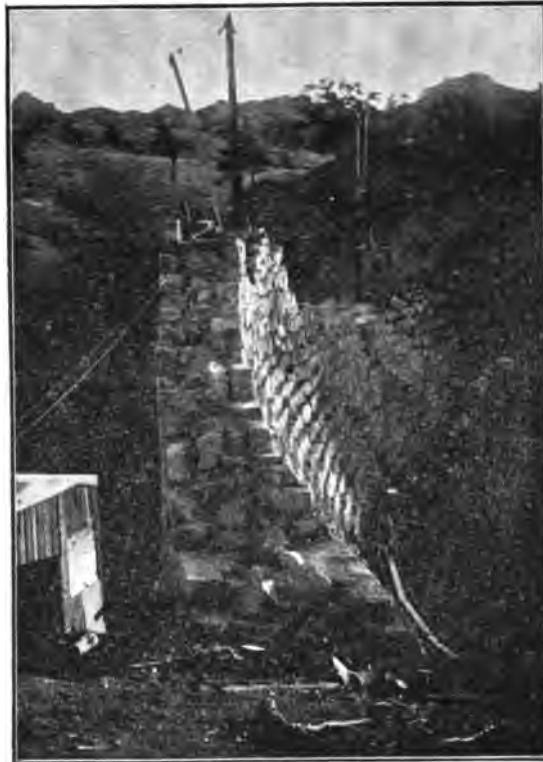
FIG. 233.—GRANITE SPRINGS DAM, WYOMING. SHOWING GENERAL CHARACTER OF RUBBLE MASONRY.

The rock used for the masonry was taken from a granite quarry 100 feet below the dam, and as taken out by blasting ranged in size from spawls to irregular shaped blocks of 4 cubic yards, averaging about 2 cubic yards. The largest rock placed in the wall contained 5 cubic yards and weighed nearly 12 tons, but rock over 3 cubic yards

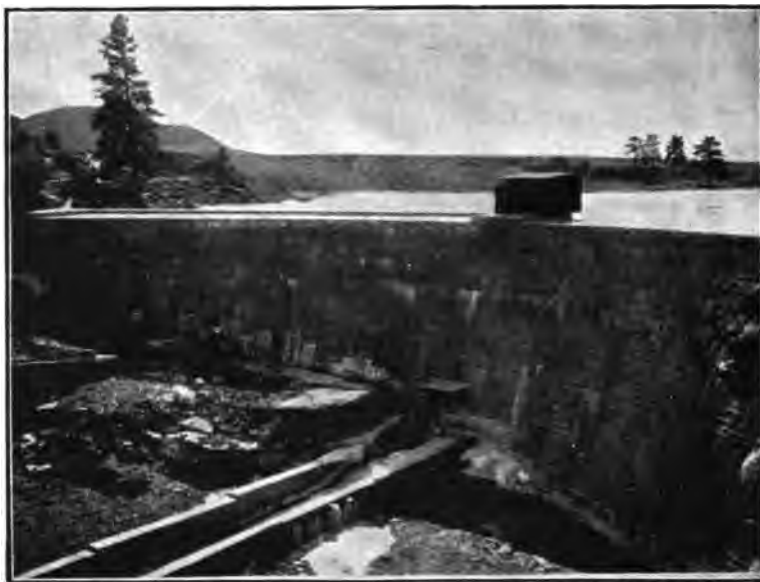
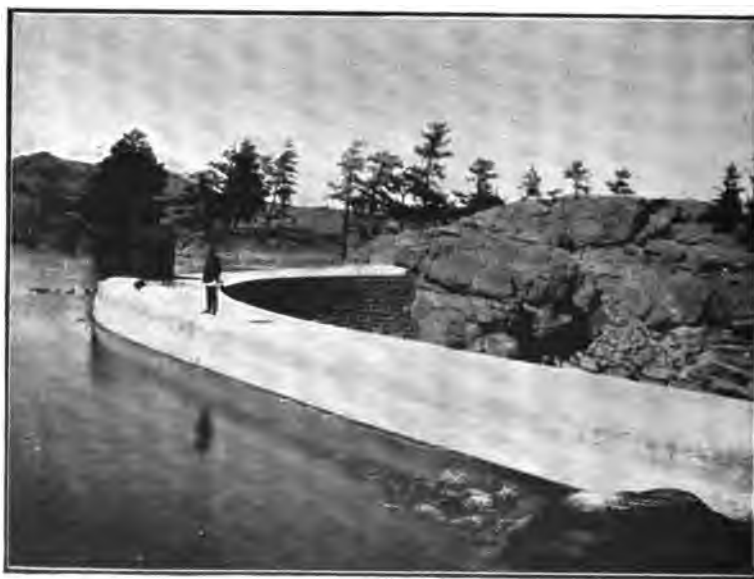
FIG. 235.—DE WEESE DAM, COLORADO

FIG. 236.—DE WEESE DAM, WET MOUNTAIN VALLEY, COLORADO.

The De Weese Dam, Colorado.—A masonry dam was built in 1905 across Grape Creek, in the Wet Mountain Valley, by Mr. Dal De Weese, for the irrigation of a tract of choice fruit-growing land on the mesa south of the Arkansas river, opposite Canyon City. The dam is curved in plan, and has a maximum height of 44 feet, the crest being at an elevation of 7755 feet above sea level. The dam is arched in plan, of gravity section, and used as an overflow weir for the greater portion of its length. The outlet of the reservoir is 31 feet below the crest. It forms a reservoir of 150 acres area, and has a storage capacity of 1700 acre-feet. Plans have been prepared by the owner for increasing the height 40 feet, and other claimants to the surplus flood waters have proposed making a still higher extension to store water to the level of 80 feet above the present crest, giving a total capacity to the reservoir of about 65,000 acre-feet.

The photographs, Figs. 235 and 236, were taken by the author in January, 1907, and show the general character of the structure.

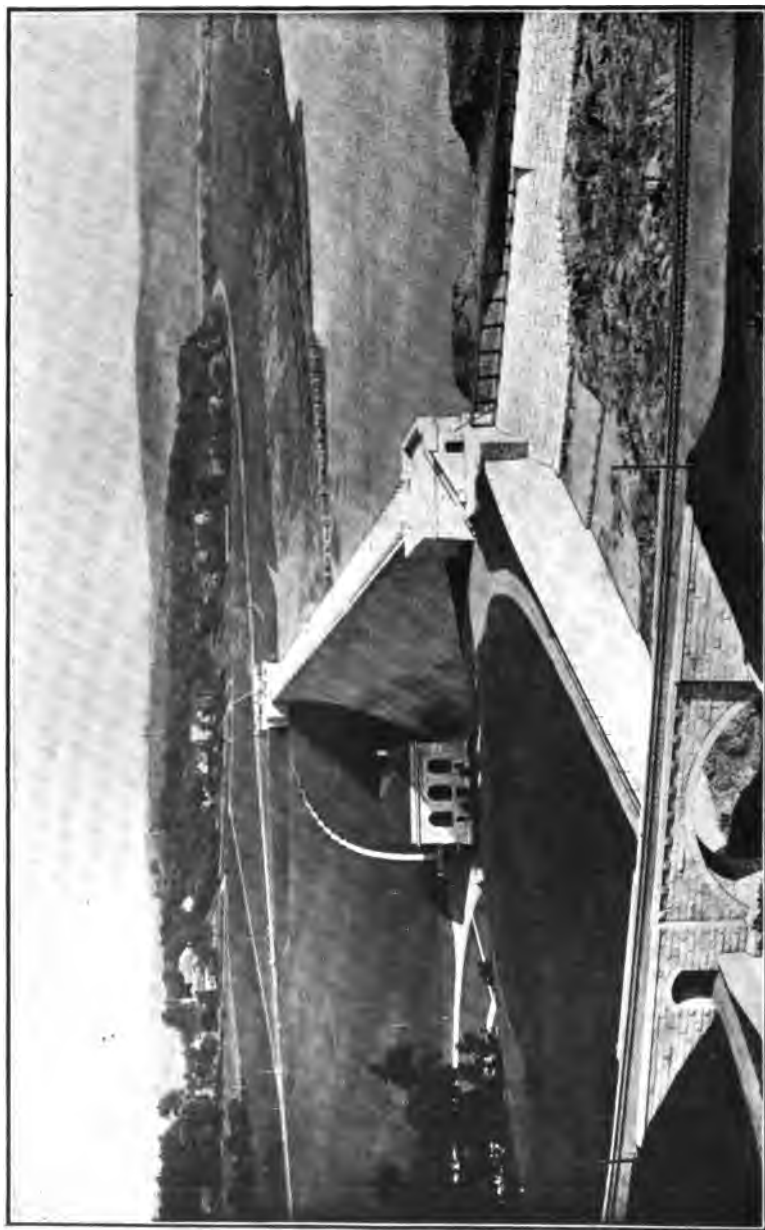
FIG. 239.—WACHUSETT DAM.

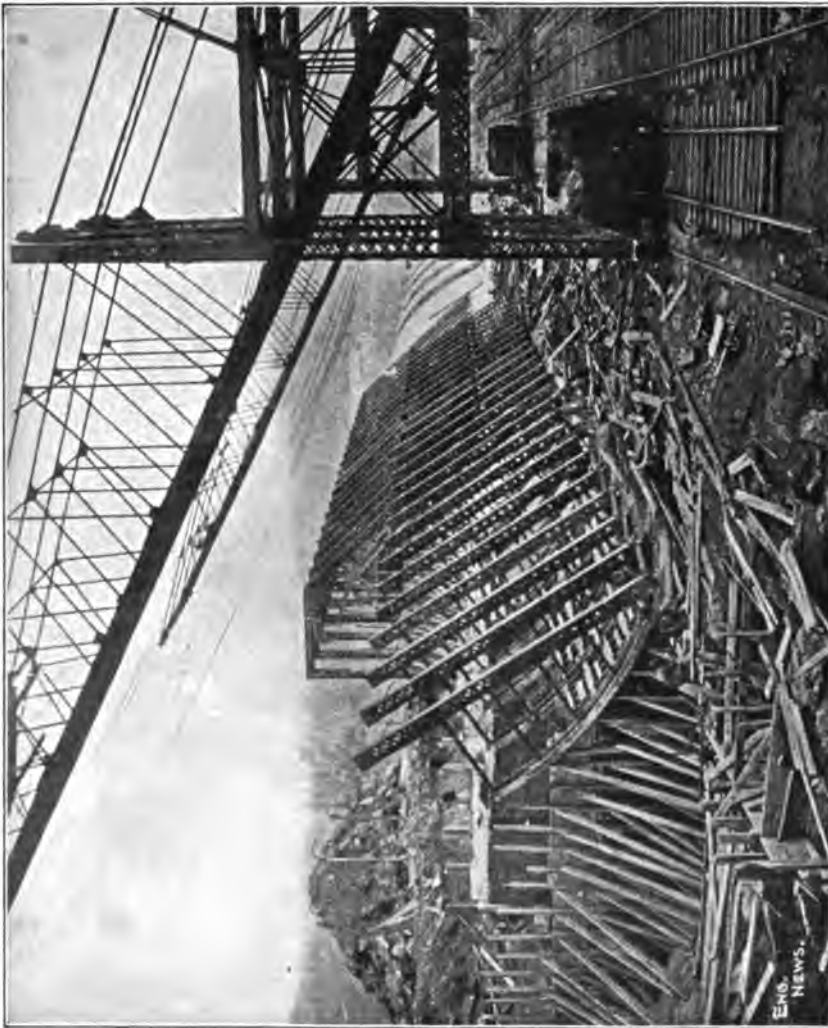
FIG. 243.—MCCALLS FERRY DAM, PENNSYLVANIA.

One of the most interesting features of construction was the substantial concrete bridge thrown across the river on a series of arches, to serve as a working platform from which to build the dam. This bridge is 50 feet wide, 2300 feet long, parallel to and 16 feet downstream from the edge of the dam

and power house. Four railway tracts of standard gauge were laid on the bridge, on which three travelling cranes, spanning all four tracks, with a base of 44 feet, are used for handling the steel forms of the dam and the material. They stand so high that cars and engines can pass underneath

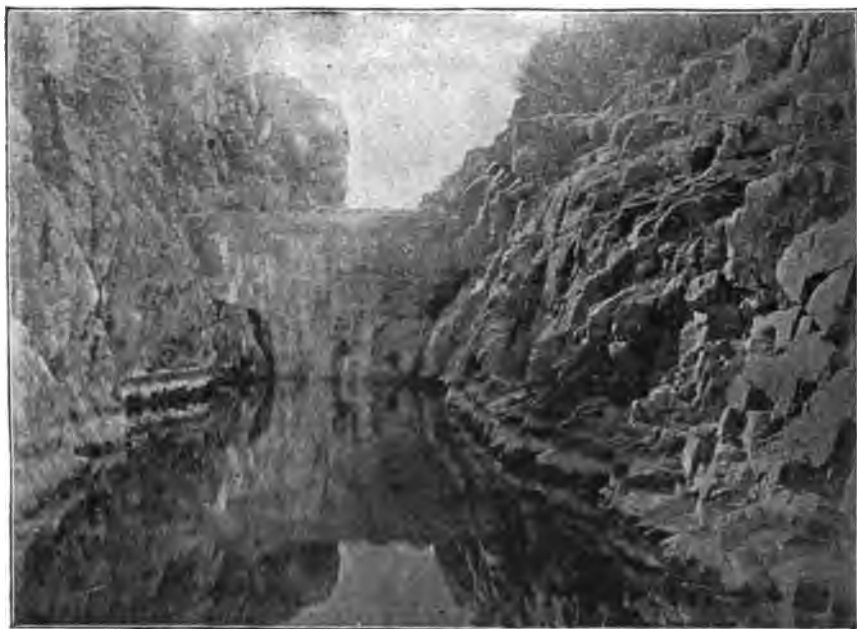
FIG. 250.—UPPER OTAY DAM. FOUNDATION MASONRY.

ervoir will touch the base of the upper dam. The width between solid rock wall at the stream bed is but 20 feet. The dam was started as a masonry structure, and was first built to a height of 34 feet (See Fig. 250).

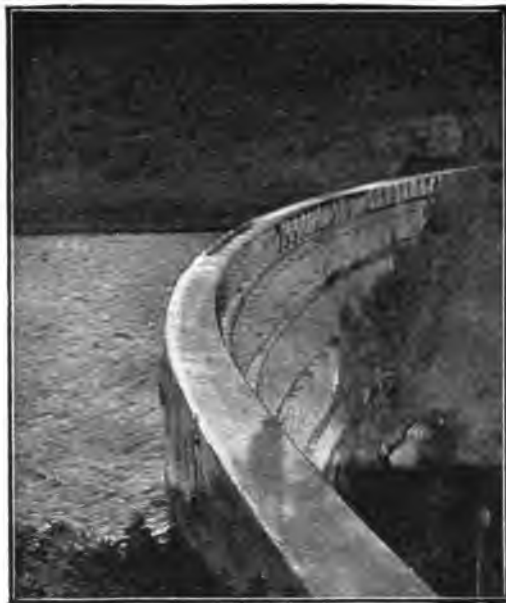
FIG. 251.—UPPER OTAY DAM, IN JANUARY, 1908.

Fig. 251 is a recent photograph of the dam, for which the writer is indebted to Mr. N. L. Hall, one of the engineering staff of the company. Fig. 252 was taken shortly after the completion of the dam.

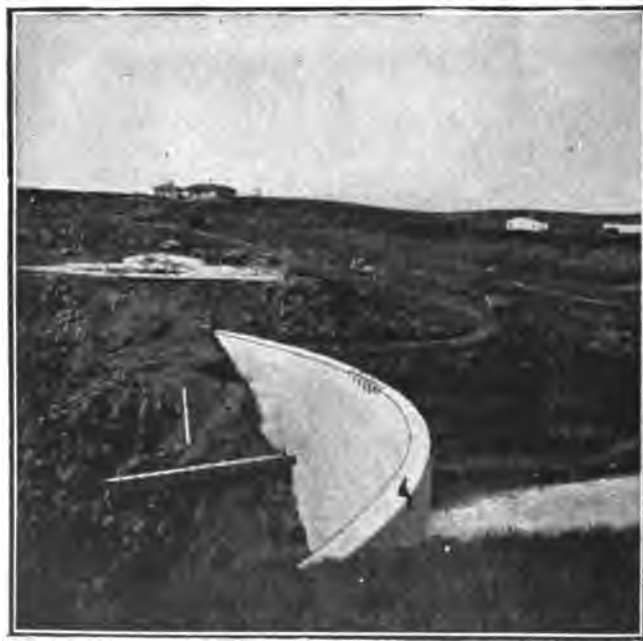
FIG. 252.—UPPER OTAY DAM.

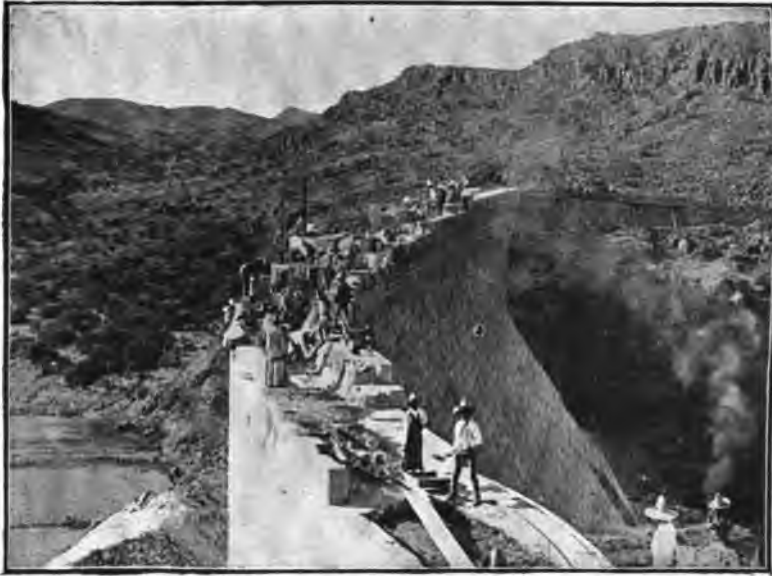
FIG. 257.—MERCEDES DAM, MEXICO, DURING CONSTRUCTION.

Figs. 256, 257, and 258 are excellent photographs, taken during construction and after completion of the dam.

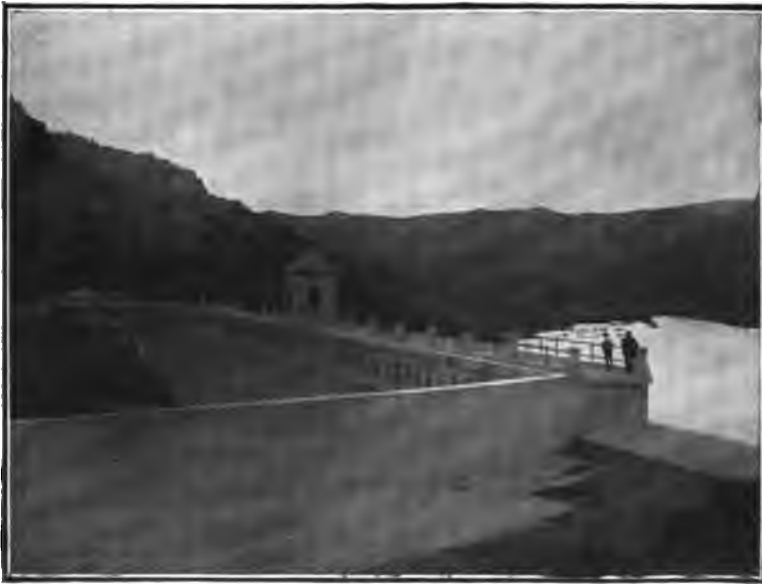
FIG. 258.—MERCEDES DAM, MEXICO, LOOKING ACROSS SPILLWAY CHANNEL, SHOWING CURVED PORTION AT FAR END.

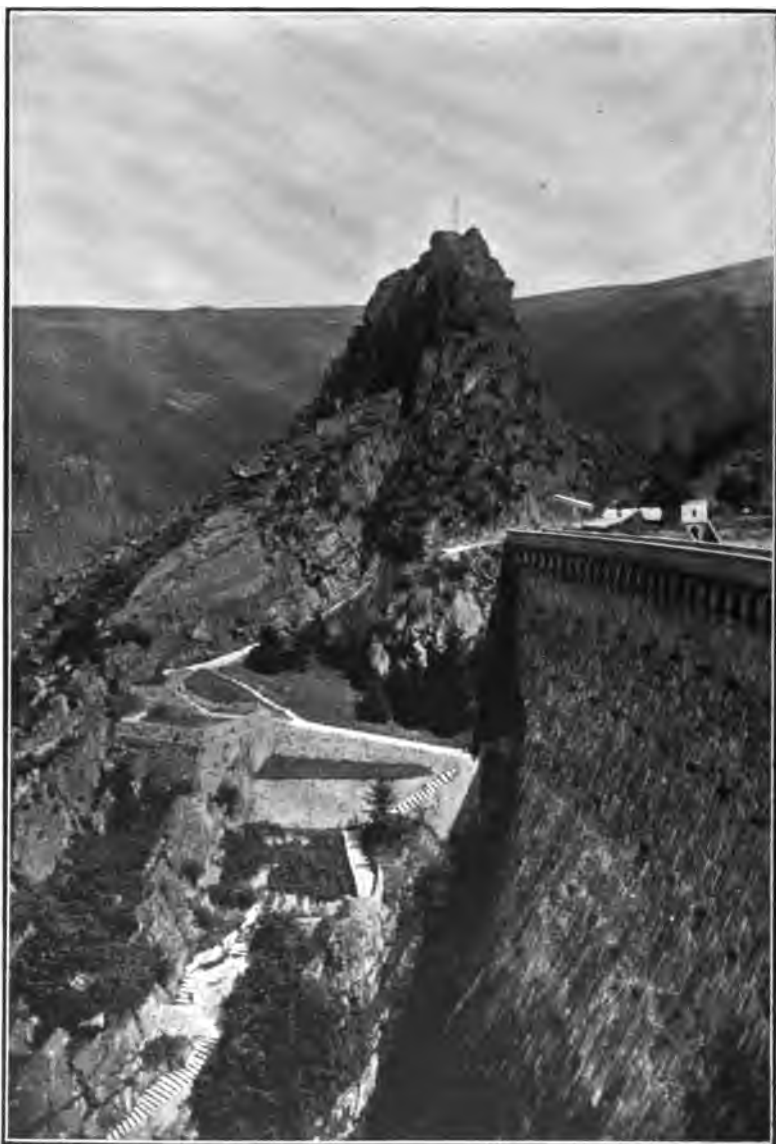
FIG. 259.—FURENS DAM, ST. ETIENNE, FRANCE, DOWN-STREAM FACE.

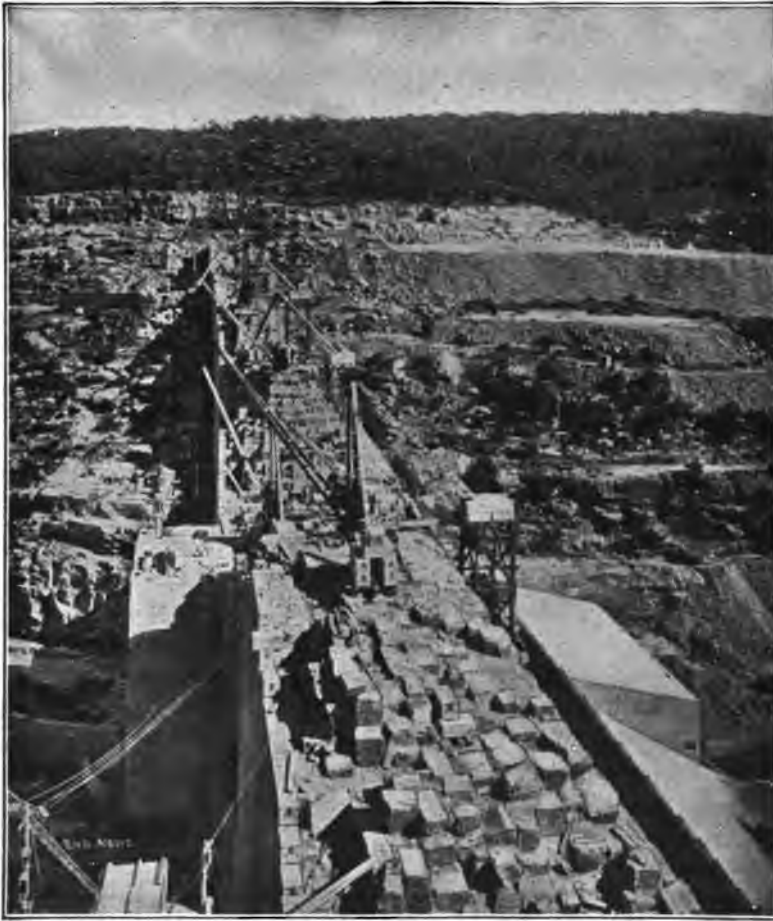
FIG. 265.—CATARACT DAM.

It is formed of cyclopean rubble masonry of blocks of sandstone weighing 2 to 5 tons, set in cement mortar, and packed in with concrete, the blocks forming about 65% of the mass. (See Fig. 265.) The up-stream face consists of concrete blocks, 5×2.5×2 feet, set in place with cement mortar, and backed with 3 feet of concrete, made of crushed basaltic stone and cement. The down-stream face is made of 6 feet of concrete, moulded

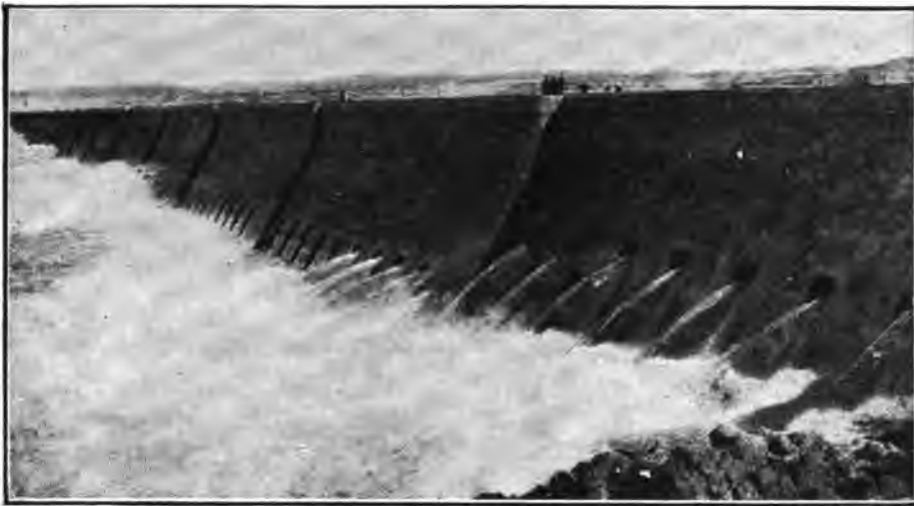
FIG. 267.—THE ASSOUAN DAM, EGYPT. SHOWING DISCHARGE THROUGH A NUMBER OF SLUICES.

Assouan Dam, Egypt (Fig. 267).—No irrigation works of modern times are more notable and far-reaching in their beneficial results upon the industrial welfare of the people than the great storage dam erected by the Egyptian Government at Assouan, on the river Nile, 700 miles above its mouth. It creates a reservoir with a capacity of 863,000 acre-feet, its effect extending back up the river a distance of 140 miles, estimating its surface slope at 1:32,000. It will thus cover an area of over 40,000 acres, a large portion of which is not over 1000 feet wide. The dam which was begun in 1898 and completed in June, 1902, is of vast proportions, being 6400 feet in length, with a maximum height of 130 feet above the lowest foundations and containing 704,000 cubic yards of masonry. The maximum depth of water in the reservoir available for draft is about 60.8 feet at the dam. The elevation of high-water level in the reservoir is 348 feet above mean tide. The dam is divided into two sections, one of which extends from the east bank for 1800 feet as a solid masonry wall without openings, while the remaining portion of 4600 feet, containing 180 sluice-ways, reaches to the west bank, and includes a navigation lock on that side. The sluice-ways are designed to carry the entire volume of the river at flood, without permitting the water to reach higher than within 9.8 feet of the top of the dam. The width of crest of the eastern solid section is 17.8 feet, while the portion in which the sluice-ways are built is 23 feet wide on top, carrying a roadway entirely across the dam. The sluice-ways are in four levels, 140 of them on the two lower levels, each being 7 meters high by 2 meters wide, while the upper banks of 40 sluices are each 2 meters

The sluices mostly are in groups of ten, with spaces of 5 meters of solid masonry between individual sluices, and 10 meters between two adjoining groups, where buttresses 26 feet wide, 3.8 feet thick, are built on each face at intervals of 240 feet. The openings or outlets being arranged at varying heights the reservoir may be drawn from near the top, without excessive head or friction to resist the opening of the gates. Sixty-five of them are placed near the bottom of the dam, with sills 70.7 feet below the floor of the roadway on top, of which forty are lined with plates of

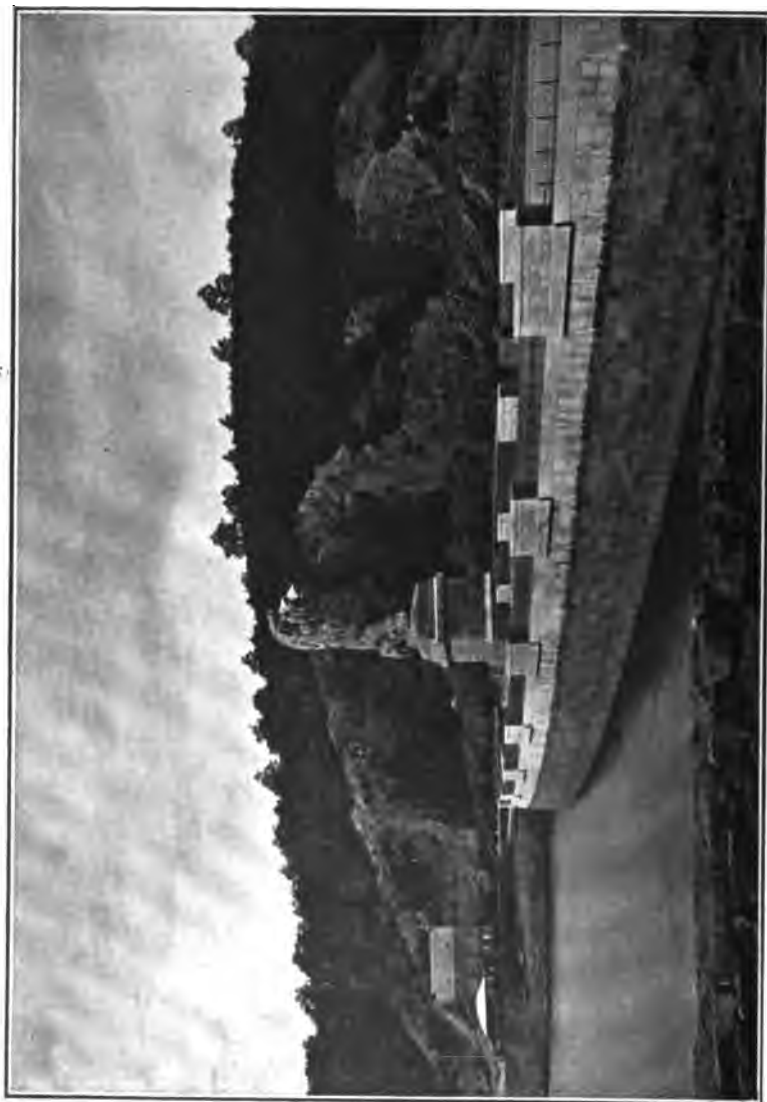
FIG. 273.—GILLEPPE DAM, VERVIER, BELGIUM.

The dam is curved up-stream on a radius of 1640 feet. It was designed by M. Bidaut, Chief Engineer, who occupied nine years in the preliminary studies before plans were submitted to the Belgian Government, by whom it was erected to regulate the flow of the Gileppe River and provide a pure-water supply for the cloth manufactories at the city of Verviers.

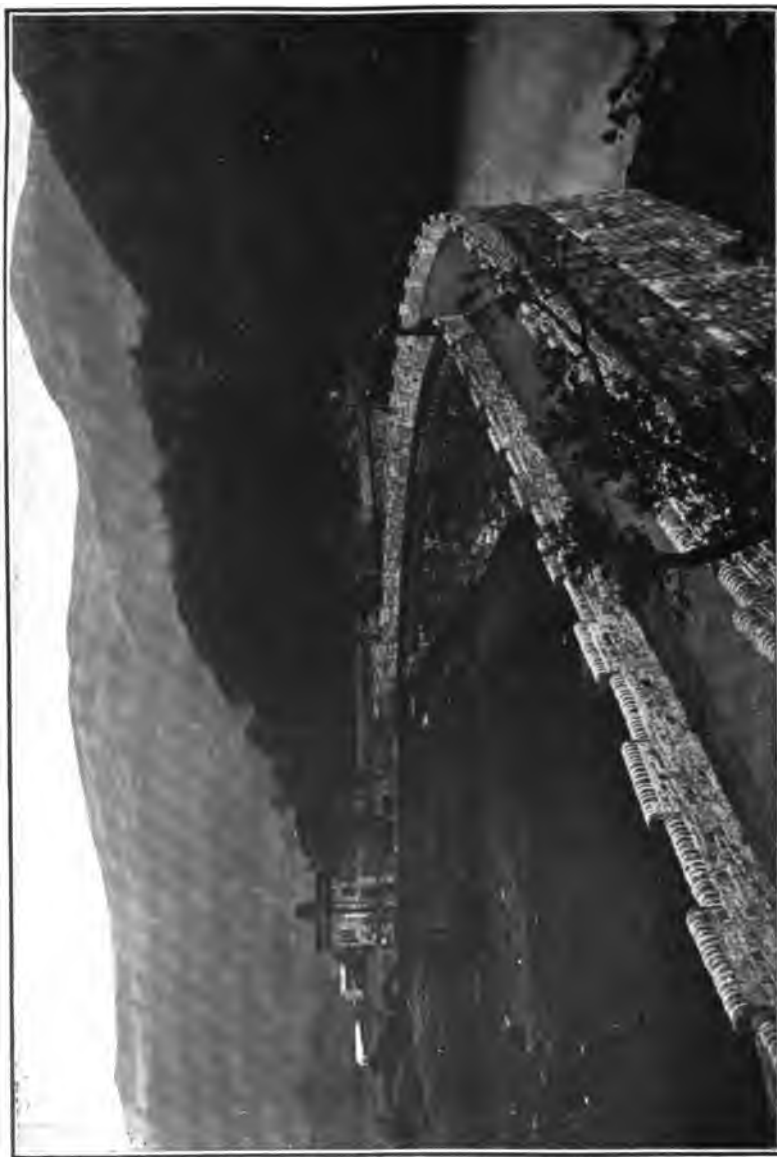
FIG. 274.—THIRLMERE DAM, ENGLAND.

Thirlmere Dam, England (Fig. 272).—A part of the water supply of Manchester is furnished from a reservoir at Thirlmere lake, formed by a masonry dam, built in 1886-1893. The dam has a maximum height of 62 feet, and is 18.5 feet wide on top, forming a roadway with masonry parapets on each side. The width of the dam at the base is 51.8 feet. The up-stream face has a batter of 12.5%, while on the down-stream side is a vertical curve with a radius of 100 feet.

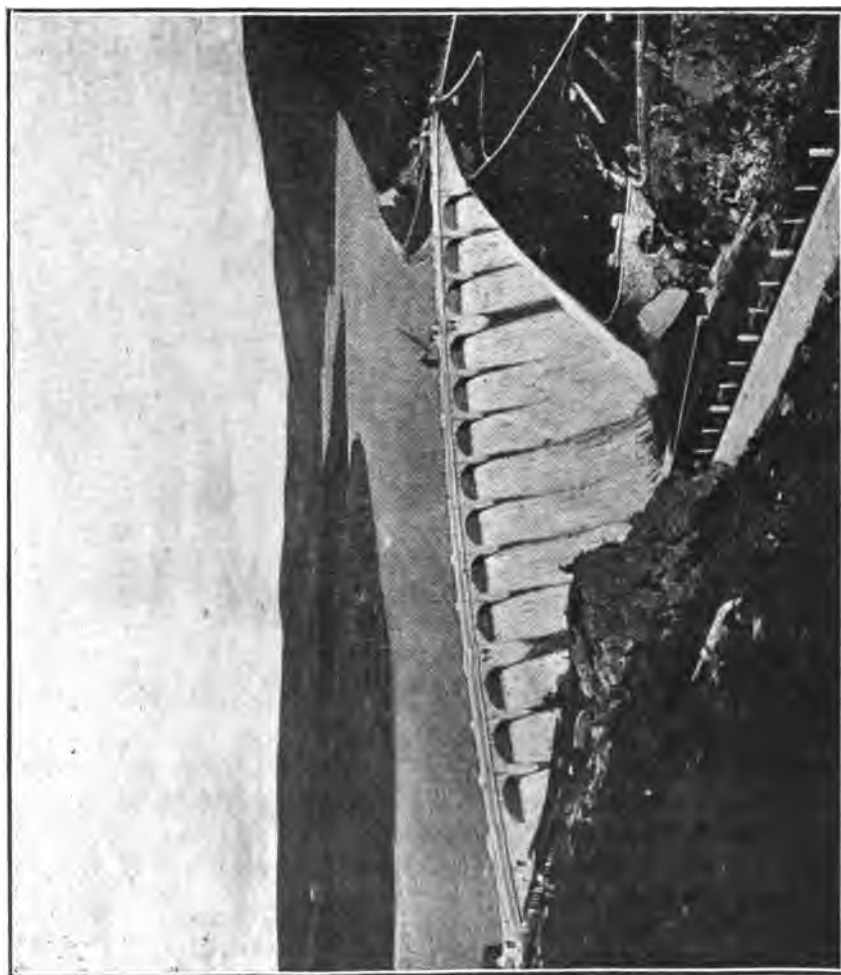
FIG. 276.—CRAIG GOCH DAM AND RESERVOIR, RADNORSHIRE, WALES, FOR BIRMINGHAM
WATER-SUPPLY.

Craig Goch Dam, Wales.—The city of Birmingham, England, has been engaged for many years past in extensive works of water storage to obtain an additional supply from the mountains of Wales, to be brought to the city by an aqueduct 74 miles long, 8 feet high inside, by 7.5 feet wide, with a capacity of 129 cubic feet per second. A total storage capacity of 66,000 acre-feet is being created by the erection of five high masonry dams, one of which, the Craig Goch dam, is illustrated by two photographs, Figs. 275 and 276, taken from *Engineering Record*, January 30, 1904. Other dams on the same stream are the Caban Goch and Pen-y-Gareg dams, which are straight in plan. The Careg-Dhu dam and one other masonry structure are located on the Clarewen river.

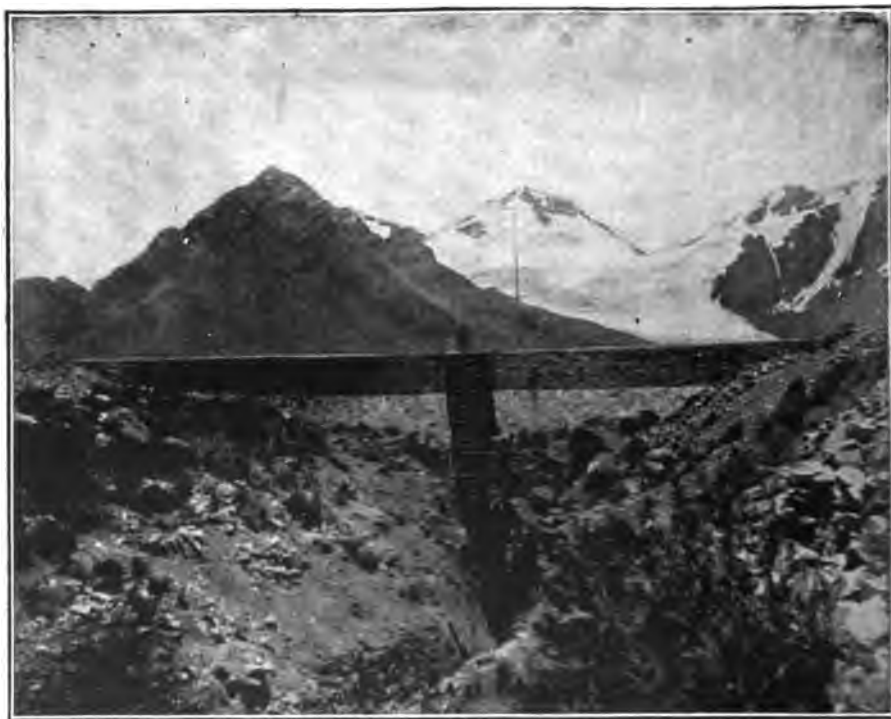
FIG. 277.—CARPA DAM, PERU, SHOWING TYPICAL OUTLET CUT, FILLED WITH STEEL BULKHEAD, GLACIER IN BACKGROUND.

Fig. 277 shows the dam from the down-stream side and the outlet cut from near the bottom to the top of the masonry, which is divided by the cut in two halves, the space being filled with a bulkhead composed of I-beams and steel plates. Water is released at the bottom of the cut through gates in the bulkhead that are raised by screw-stems reaching to the top.

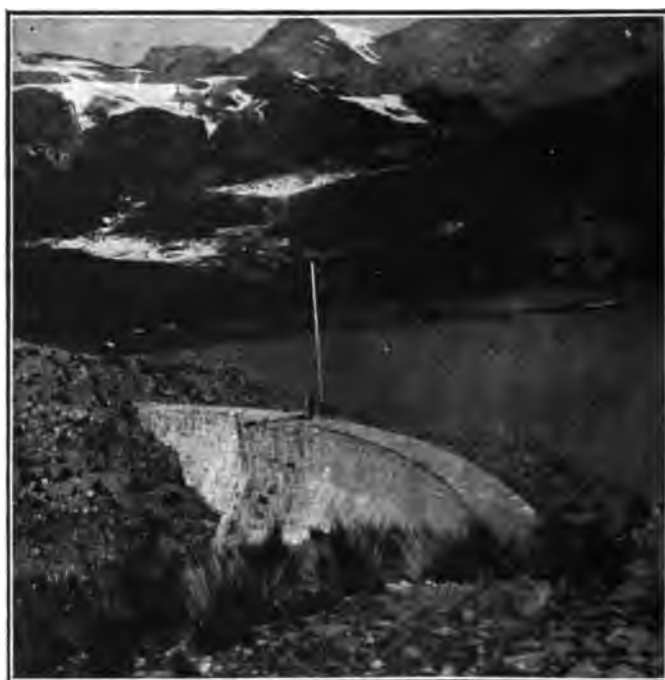
FIG. 278.—QUISHA DAM, PERU.

Lake Quisha Dam.—About a mile above lake Carpa reservoir and 300 feet higher in elevation, is lake Quisha which has been converted into a storage reservoir by a dam quite similar in construction to the works at lake Carpa. The cut to drain the lake is 10.6 meters deep and the dam 6 meters high, a total of 16.6 meters (54.5 feet). The dam has the same section as the Carpa dam with a crest length of 48 meters and a volume of 887 cubic meters of masonry. It is also curved up-stream, with a radius of 66 meters. The water-shed tributary to the lake is but 3 square miles, and the annual run-off is so much less than the reservoir capacity that the water has never reached within 5 meters of the top of the dam. The capacity of the lake is 8035 acre-feet, while the maximum amount stored has been 5654 acre-feet. As this dam is on the same water-shed as the Carpa dam, and the total annual run-off of the tributaries of both is less than the capacity of Carpa lake reservoir, it is evident that the Quisha dam was not required, and its cost—over \$125,000—was a useless expenditure. The elevation of the lake is 15,400 feet above sea level. Fig. 278 shows the entire dam and a portion of the lake. Incidentally it conveys an idea of the scenic grandeur with which the lake is surrounded.

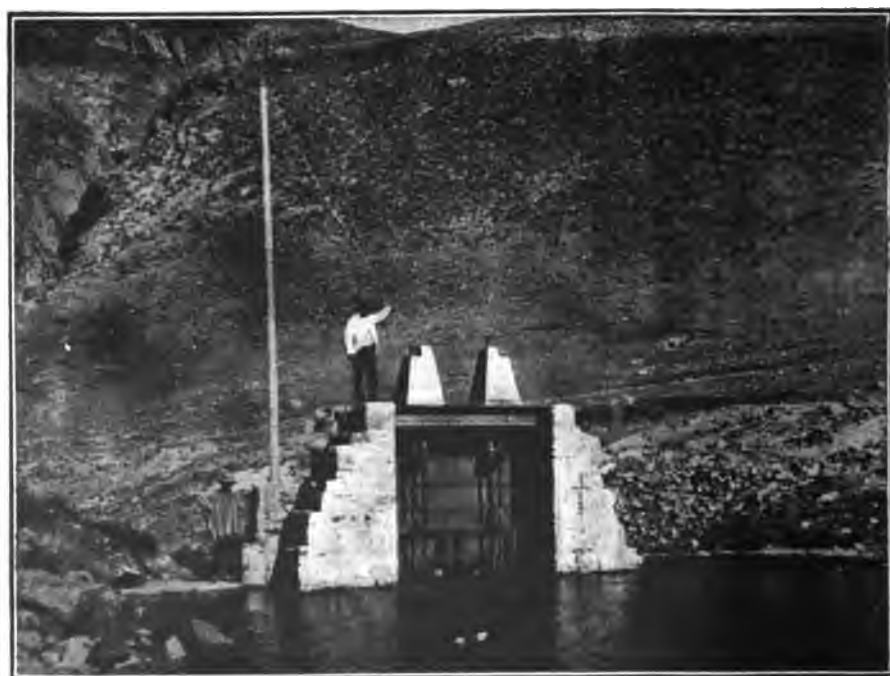
FIG. 279.—SACSA DAM, PERU, DESIGNED TO BE INCREASED IN HEIGHT 8 FEET, SHOWING GATES. 412

to the storage capacity of the lake. The excavation of the cut required the removal of nearly 18,000 cubic meters of clay, gravel and rock, the cost of which, with the 173 cubic meters of masonry around the gates, and including the latter, was over \$250,000. The photograph (Fig. 279)

clearly shows the typical plan of outlet gates used on all the reservoirs. The other six reservoirs, Huasca, Bucro, Mischa, Huachua, Manca, and Pichua, are natural lakes, converted to use by merely making outlet cuts and erecting controlling gates. Fig. 280 is typical of all of these, and shows the iron work of the bulkhead in the cut, in which the gates are placed at Huasca lake reservoir—the largest of the six, having a capacity of 4228 acre-feet. The total expenditure on these works by the Government was \$983,000. The enormous unit prices paid for the works is suggestive of official graft on an extensive scale.

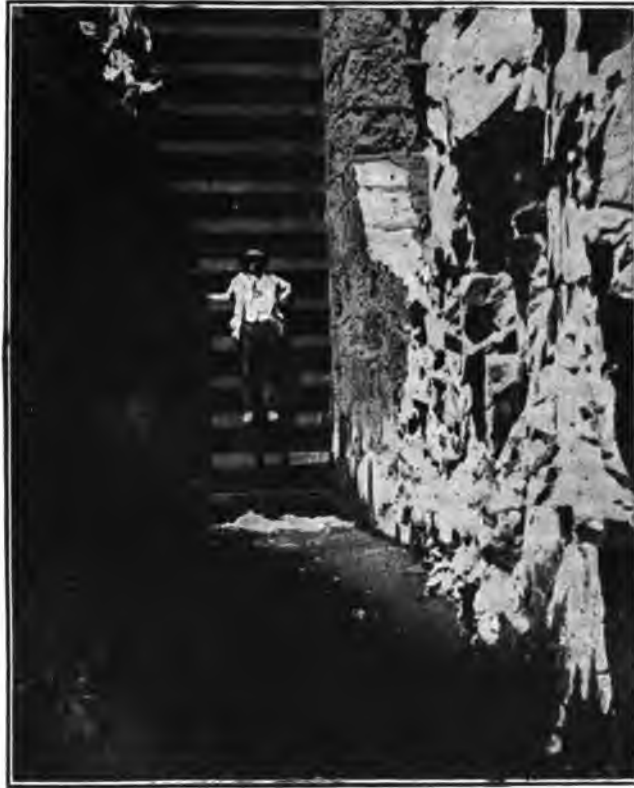
FIG. 280.—HUASCA DAM, PERU, ILLUSTRATING TYPE OF IRON BULKHEADS USED IN OUTLET CUTS OF ALL NINE LAKES USED AS RESERVOIRS.

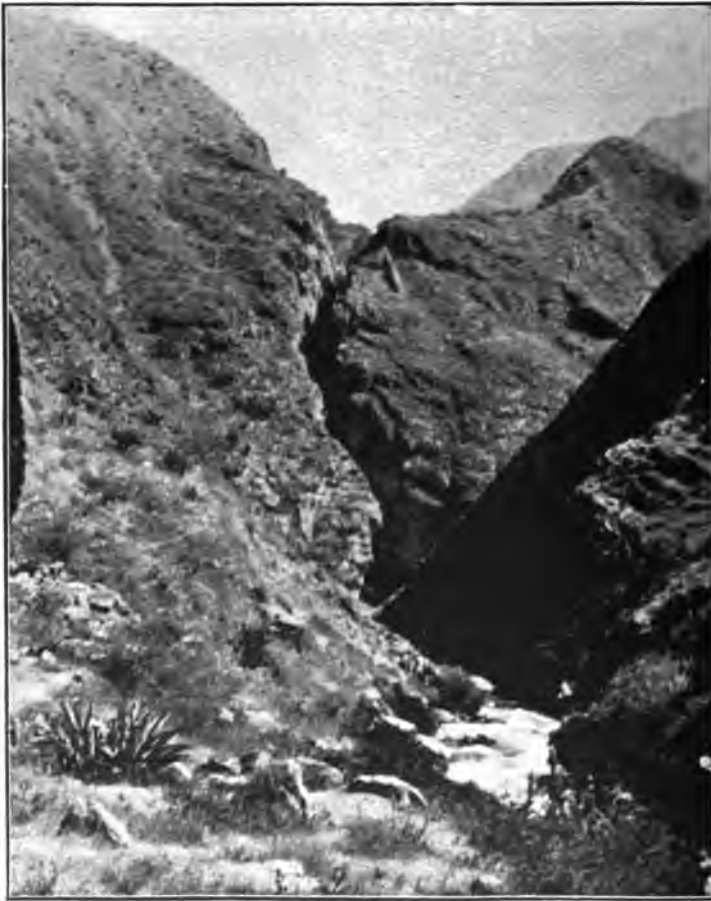
FIG. 281.—AUTISHA DAM SITE, SANTA EULALIA RIVER, PERU—A MOST REMARKABLE GORGE.

of unprecedented height. Fig. 281 is a view of this phenomenal canyon, and Fig. 282 is a photograph of the reservoir basin above the dam. The opportunity for water power development is also remarkable on these rivers, which fall so very precipitously toward the west. One branch of the Rimac river falls 7300 feet in a distance of 35 miles, with a minimum flow of 250 sec.-feet, capable of developing 200,000 H. P. This is a fair illustration of nearly all the rivers of Peru flowing into the Pacific Ocean.

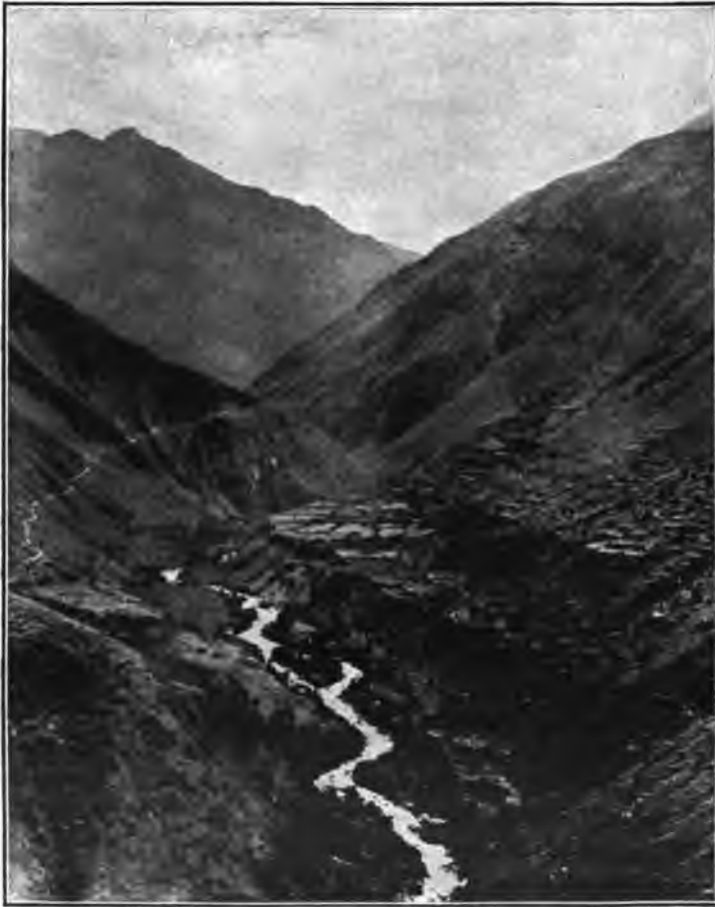
FIG. 282 —RESERVOIR SITE ABOVE PROPOSED AUTISHA DAM, PERU.

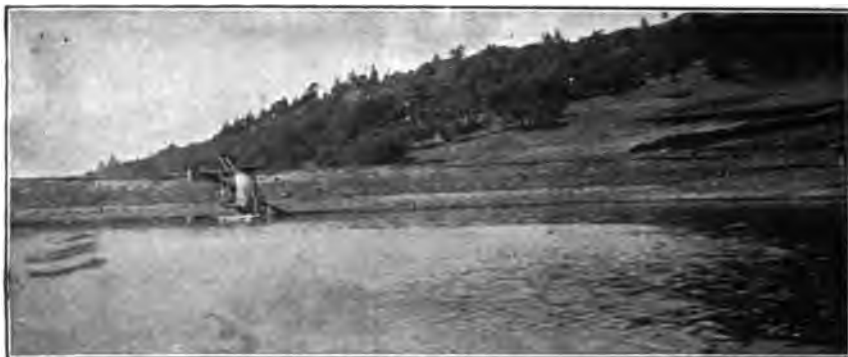
FIG. 285.—VIEW OF CUYAMACA DAM AND OUTLET-TOWER.

Fig. 285 is a view of the dam from the side of the reservoir, showing the tower.

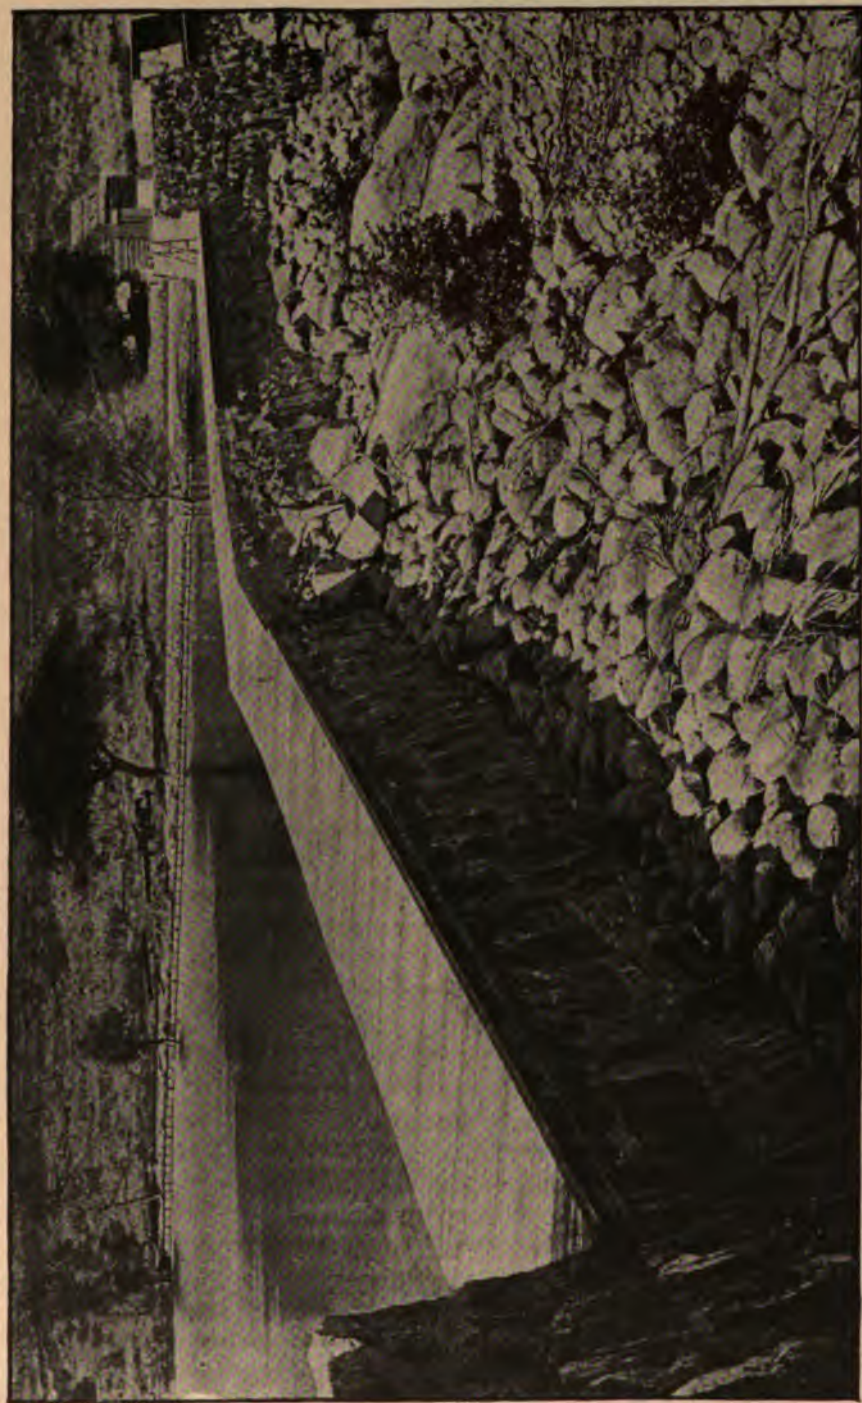
FIG. 286.—MASONRY DIVERTING-DAM OF THE SAN DIEGO FLUME CO., CALIFORNIA.

After flowing down Boulder Creek and the San Diego River $12\frac{1}{2}$ miles, dropping 4000 feet vertically in that distance, the water released at the dam is picked up and diverted to the flume by means of a masonry weir extending across the San Diego River. This diverting-dam is 340 feet long on top, 35 feet high, 22 feet thick at base, 5 feet at the crest. To cut off leakage under the dam a subwall was built on the up-stream side in the main channel, lapping onto the base of the dam and extending down 15 feet deeper. This wall is 5 feet thick at bottom. The original wall had been founded on disintegrated granite. The subwall was built in a trench that cut deeper into the soft granite, but was not entirely effectual in stopping the leakage. (Figs. 286 and 287.)

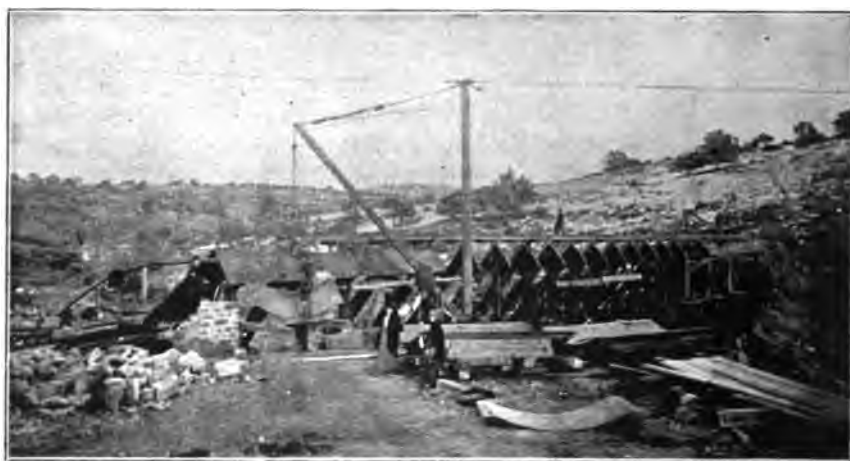
FIG. 294.—ASH FORK, ARIZONA, STEEL DAM, VIEW OF STEEL CONSTRUCTION FROM LOWER SIDE.

Figs. 294 and 295 give an excellent general idea of the construction. Fig. 296 shows a portion of the reservoir, and represents clearly the igneous rock formation of the canyon in which it is located.

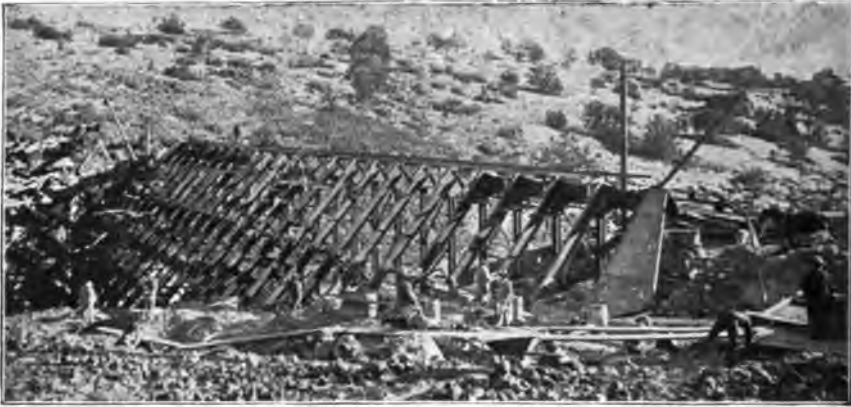
FIG. 295.—ASH FORK, STEEL DAM, SHOWING FRAME READY TO RECEIVE PLATES.

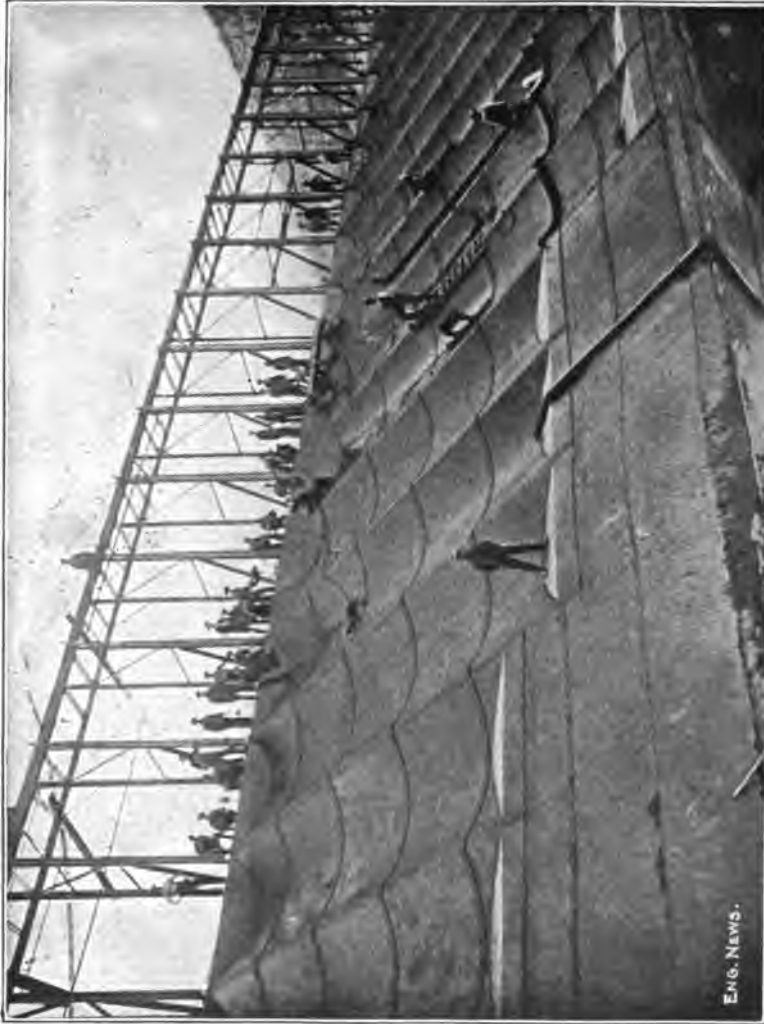
FIG. 300.—HAUSER LAKE DAM, MONTANA.

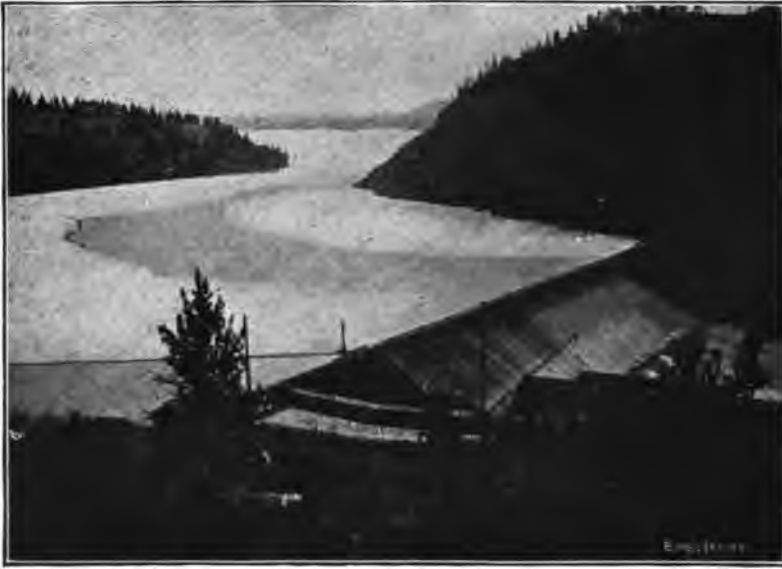
FIG. 302.—COMPLETED HAUSER LAKE DAM NEAR HELENA, MONT.

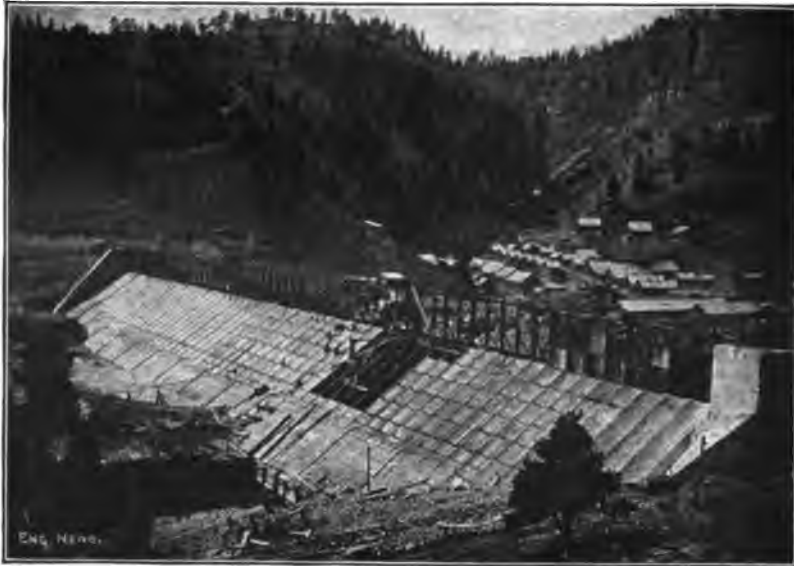
FIG. 303.—HAUSER LAKE DAM, MONTANA, NEARING COMPLETION.

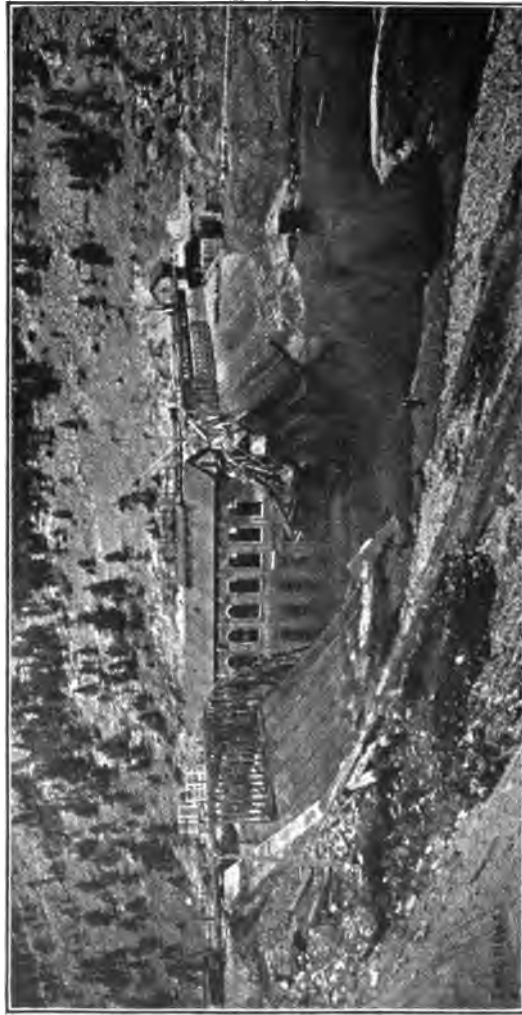
FIG. 304.--VIEW OF THE WRECKED HAUSER LAKE DAM, IN APRIL, 1908.

Failure of the Hauser Lake Dam, Montana.—The new steel dam built on the Missouri river, about 18 miles from Helena, Mont., described on page 499, and but recently completed, was partially destroyed on April 14, 1908, subsequent to the preparation of the description, and a section about 300 feet wide in the center of the dam was washed out. The failure, as described in *Engineering News*, April 30, 1908, with photographs of the ruined structure, was caused by water undermining the rubble masonry fill and the steel sheet-piling at the up-stream toe of the dam. This piling had been used over a portion of the channel where bed-rock could not be reached and where the gravel of the river-bed is of great depth. The maximum depth reached by the piling driven in this gravel was 35 feet. The concrete placed over the top of the piling, which formed the junction between the expansion joint of the steel work and the sheet piling, is said to have been placed in a depth of 10 feet or more of water, so that its quality may have been very poor. The total damage caused by the break is estimated at \$250,000 to \$300,000, requiring six months time to make the necessary repairs. Figs. 302 and 303 illustrate the dam as completed, and just prior to completion. The wreck of the dam is clearly shown by Figs. 304 and 305. These interesting cuts have been kindly loaned by *Engineering News*.
